Barrick Bald Mountain Tire Shop

Location: White Pine County, Nevada

Submitted by: Suncoast Post-Tension, Ltd.

Overview:

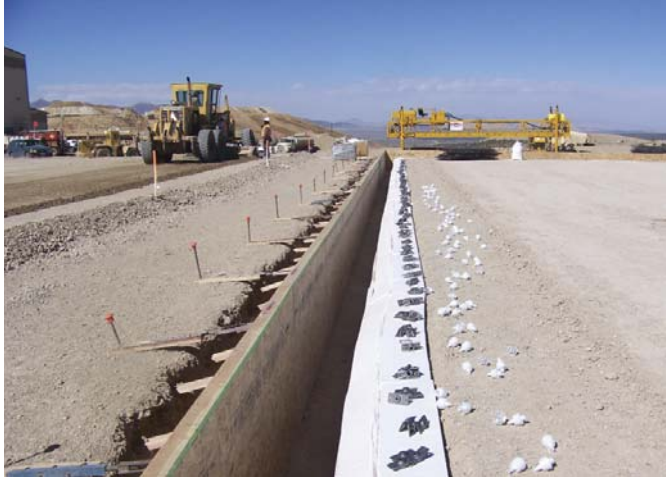
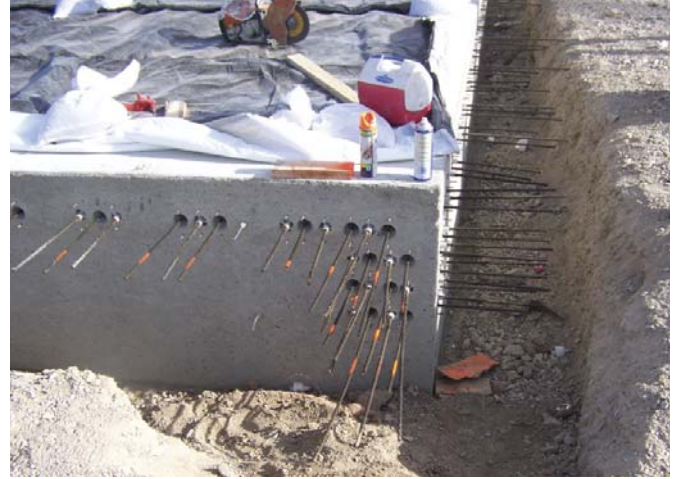
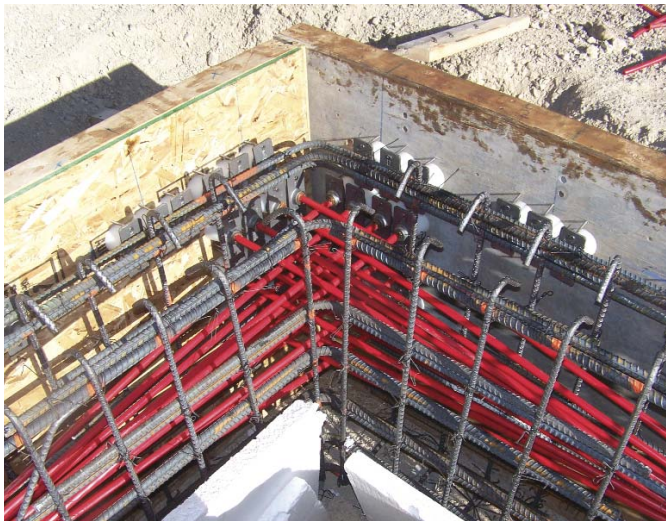
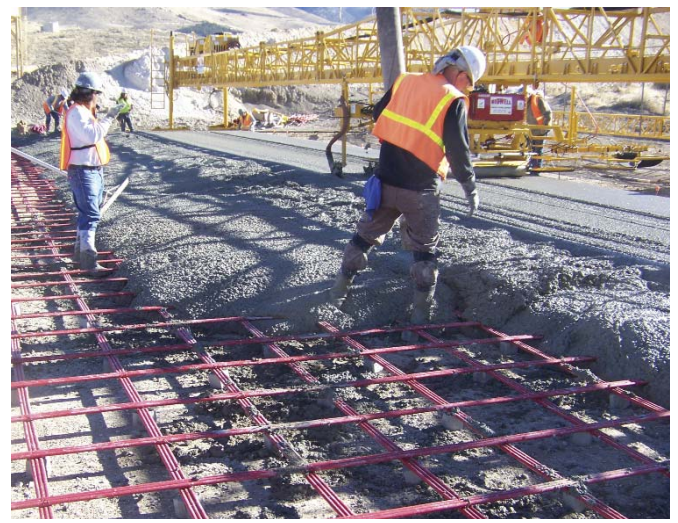
Two concrete slabs were constructed for the changing of tires on haul trucks, as well as to host the building structure of a tire shop. The design required a 12-foot-by-14-foot slab with 18-foot-by-48-foot exterior beams. Every 18-feet, the slab tendons were placed in bundles of three, with up to 12 tendons in the exterior beams. Concrete had to be mixed on-site at 5,000-psi because of the remote location of the mine. Additionally, custom subgrade fill was necessary to optimize the post-tension design and to meet a subgrade reaction rate of 500-pci (k-value). Project managers were impressed by the installation performed by PTI certified crews, as they encountered no issues with placement or stressing of the concrete. Completed in October 2007, the tire shop and changing pad will allow the Barrick Corporation to continue service to more than 250-square-miles of claims, which produced 300,000 ounces of gold in 2006.
